**Flood Control Project Maintenance
Levee Inspections**
LMA District Cover Sheet
Spring 2018 Levee Inspection Results

Reclamation District No. 0785 Driver

Levee Inspection Report By Mile - Spring 2018

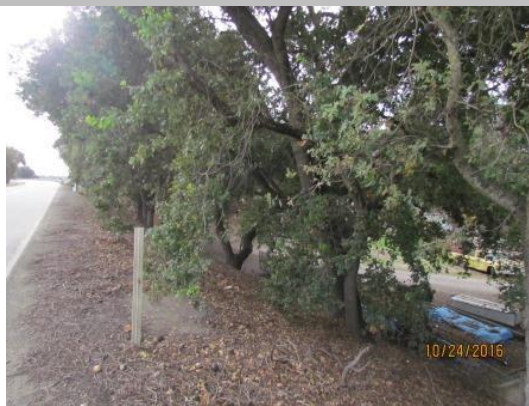
Photo 1 of 1 : SP_2018_RD0785_185_22_20180306_00016.jpg

LM Start	1.61	Rating **	M	Issue No.	22
LM End	1.62	Issue Type +	Ma	Location *	LS
Category	Earthen Levee			GPS Latitude/Longitude	
				Start	End
Item	Trim / Thin Trees			38.643359 °	38.643229 °
				-121.595237 °	-121.595011 °
DWR ID	DWR_RD0785_01_s_2016_22				
Comment Code					
T1 : Trim trees to at least five feet above ground level.					
Inspector Comment					
Trees still need trimming.
